Cyclic Fatigue Testing of Surface Mooring Hardware for the Arabian Sea Mixed Layer Dynamics Experiment

UOP Technical Report 95-5

WHOI-95-16 UOP 95-05

December 1995

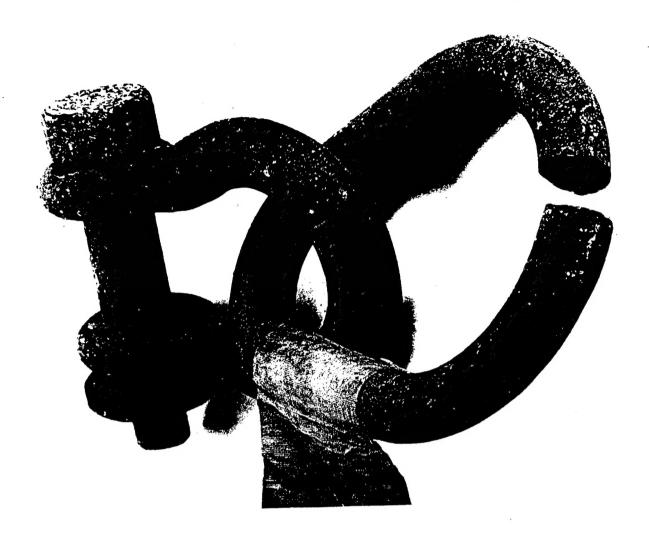
Little was known about the fatigue properties of standard components used in-line on a mooring prior to the 1989 pilot mooring for the Office of Naval Research (ONR) funded Marine Light in the Mixed Layer (MLML) experiment (Plueddemann *et al.*, 1995). The MLML pilot mooring was deployed in April 1989, approximately 300 miles south of Iceland in 2845 meters of water. Though the mooring was intended to remain on station for 5 months it failed after only 70 days. A 5/8 inch Crosby Laughlin weldless sling link with a rated working load of 4200 pounds and an ultimate breaking strength of six times the working load limit (WLL) was the component that failed (Figure 1). A high frequency tension data logger at the base of the MLML pilot mooring buoy bridle recorded tensions that ranged from less than 1000 to over 8500 pounds which was well under the ultimate breaking strength of the sling link. Tension records showed changes of up to 5000 pounds over less than four seconds.

To investigate this problem the manufacturer of the slings links, Crosby, agreed to perform a series of cyclic tests at their facility in Tulsa, Oklahoma, on the 5/8" sling links. Links were cycled between 2000 and 4000 pounds at 5 cycles per second. Inspections were made after 500,000, 1,000,000, and 2,000,000 cycles; however there were no obvious changes. The loading was changed to cycle between 420 and 6300 pounds, i.e., from a low load equal to 10% of the WLL to a high load equal to 1.5 times the WLL. Failure occurred after 52,800 cycles.

Figure 1: Photograph and manufacturer specifications of the 5/8" weldless sling link that failed during the 1989 deployment of the Marine Light in the Mixed Layer experiment pilot mooring.

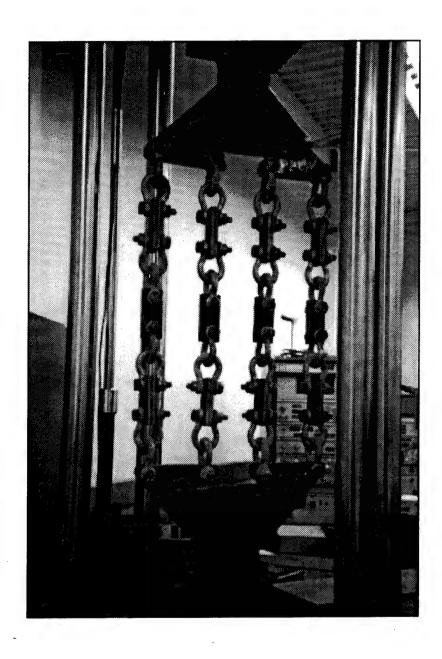
Figure 2: Photograph of the cyclic fatigue test setup while testing four strings of shackles.

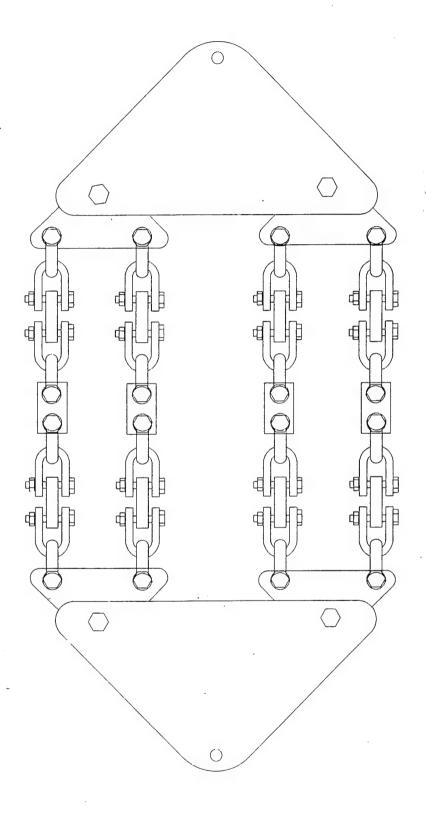
Figure 3: Schematic of the "wiffle tree" configuration used during the fatigue testing of multiple strings of hardware components. Shown here are four strings of shackles with WHOI fabricated steel plate interconnecting links.

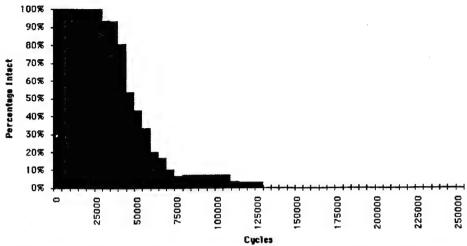
Figure 4a. 5/8" Weldless Sling Links cycled between 400 and 6300 pounds. The blackened section depicts the percentage of samples intact at the cycles indicated. The sample size was 30 and the test was terminated at 126,400 cycles with no intact samples remaining.

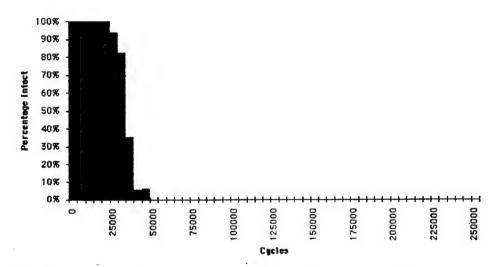
Figure 4b. 5/8" Weldless Sling Links cycled between 400 and 7200 pounds. The blackened section depicts the percentage of samples intact at the cycles indicated. The sample size was 17 and the test was terminated at 46,550 cycles with no intact samples remaining.

The 5/8" weldless sling links failed as early as 21,250 cycles when loaded between 400 and 7200 pounds. This is equivalent to 1.7 days assuming the waves creating such loads have a 7 second period. The 3/4" weldless sling link did not have a much better showing. In comparing hardware of the same size that was tested at the same load ranges the weldless sling link always failed after fewer cycles.

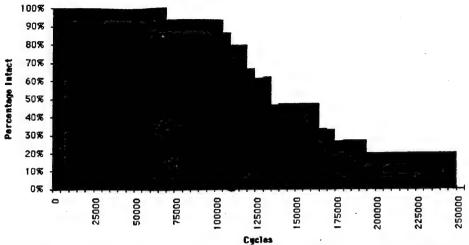
Figure 4c. 3/4" Weldless Sling Links cycled between 400 and 7500 pounds. The blackened section depicts the percentage of samples intact at the cycles indicated. The sample size was 15 and the test was terminated at 240,520 cycles with three intact samples remaining.

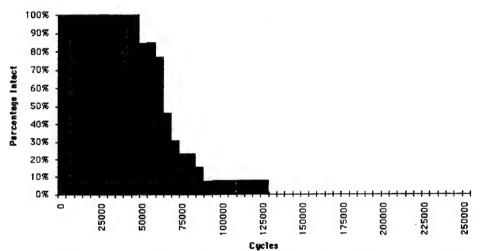
Figure 4d. 3/4" Weldless Sling Links cycled between 400 and 8800 pounds. The blackened section depicts the percentage of samples intact at the cycles indicated. The sample size was 13 and the test was terminated at 128,700 cycles with one intact sample remaining.

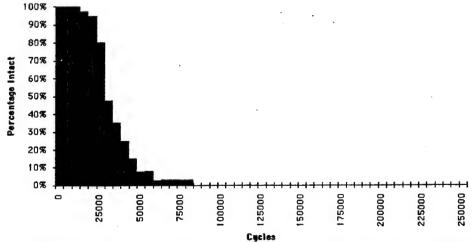
Figure 4e. 3/4" Weldless Sling Links cycled between 400 and 10,200 pounds. The blackened section depicts the percentage of samples intact at the cycles indicated. The sample size was 40 and the test was terminated at 82,270 cycles with no intact samples remaining.

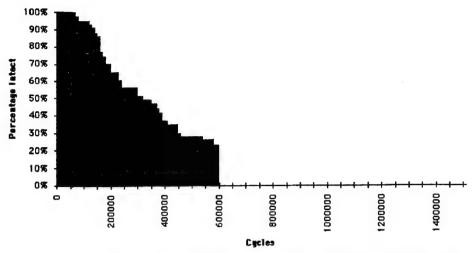
Figure 4f. 5/8" Anchor Shackles cycled between 400 and 6300 pounds. The blackened section depicts the percentage of samples intact at the cycles indicated. The sample size was 43 and the test was terminated at 582,680 cycles with ten intact samples remaining.

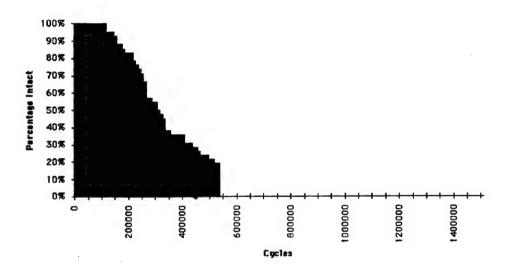
Figure 4g. 5/8" Anchor Shackles cycled between 400 and 7200 pounds. The blackened section depicts the percentage of samples intact at the cycles indicated. The sample size was 42 and the test was terminated at 522,820 cycles with eight intact samples remaining.

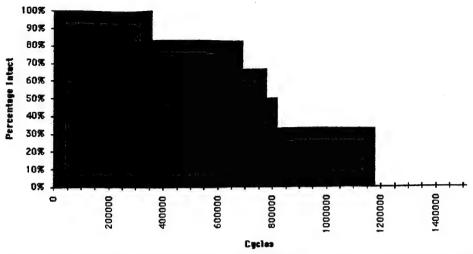
Figure 4h. 3/4" Anchor Shackles cycled between 400 and 6800 pounds. The blackened section depicts the percentage of samples intact at the cycles indicated. The sample size was 6 and the test was terminated at 1,165,930 cycles with two intact samples remaining.

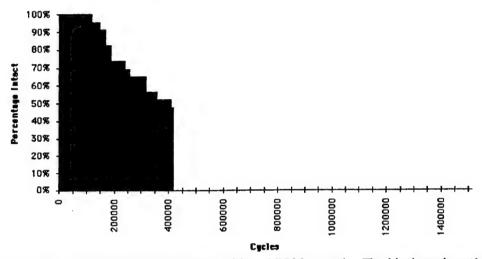
Figure 4i. 3/4" Anchor shackles cycled between 400 and 7500 pounds. The blackened section depicts the percentage of samples intact at the cycles indicated. The sample size was 23 and the test was terminated at 402,490 cycles with eleven intact samples remaining.

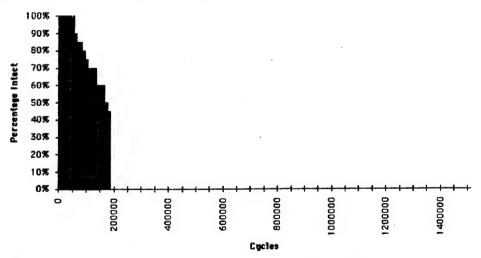
Figure 4j. 3/4" Anchor Shackles cycled between 400 and 8800 pounds. The blackened section depicts the percentage of samples intact at the cycles indicated. The sample size was 20 and the test was terminated at 170,090 cycles with eight intact samples remaining.

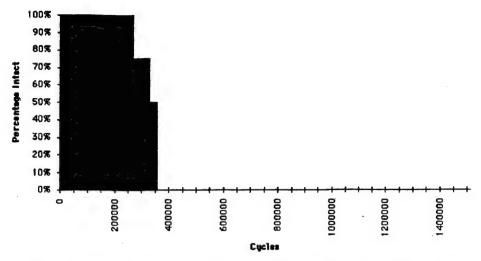
Figure 4k. 3/4" Chain Shackles cycled between 400 and 6800 pounds. The blackened section depicts the percentage of samples intact at the cycles indicated. The sample size was 4 and the test was terminated at 344,320 cycles with two intact samples remaining.

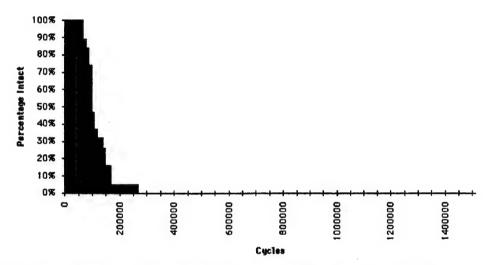
Figure 4I. 3/4" Chain Shackles cycled between 400 and 10,200 pounds. The blackened section depicts the percentage of samples intact at the cycles indicated. The sample size was 19 and the test was terminated at 258,040 cycles with one intact sample remaining.

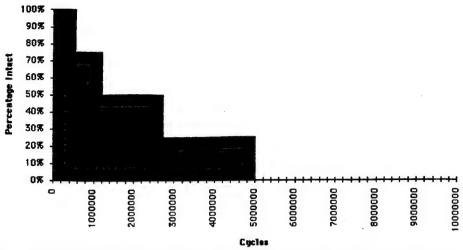
Figure 4m. 5/8" Shot Peened Anchor Shackles cycled between 2000 and 6000 pounds. The blackened section depicts the percentage of samples intact at the cycles indicated. The sample size was 4 and the test was terminated at 5,000,000 cycles with one intact sample remaining.

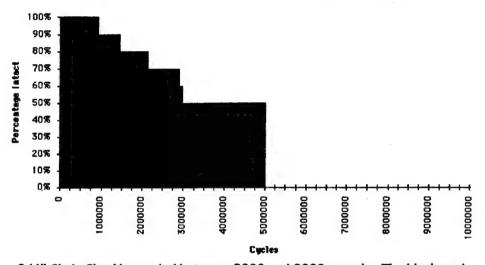
Figure 4n. 3/4" Chain Shackles cycled between 2000 and 6000 pounds. The blackened section depicts the percentage of samples intact at the cycles indicated. The sample size was 10 and the test was terminated at 5,000,000 cycles with five intact samples remaining.

Thirteen galvanized 3/4" Crosby chain shackles were cycled between 2000 and 6000 pounds. The first failure occurred after 911,320 cycles. One of the thirteen shackles tested was a replacement for a failed component and was still intact when the test was terminated after only accumulating 570,490 cycles. Since it had not failed and did not reach the minimum number of cycles to the first failure we have disregarded it here. Of the remaining 12 shackles five or 42% failed between 911,320 and 2,972,720 cycles. The same percentage were intact after 5,000,000 cycles.

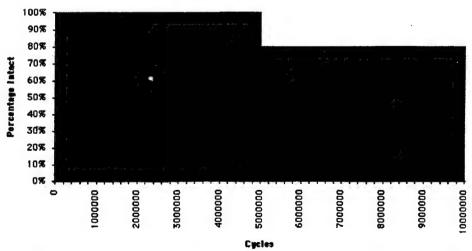
Figure 4o. 3/4" Shot Peened Chain Shackles cycled between 2000 and 6000 pounds. The blackened section depicts the percentage of samples intact at the cycles indicated. The sample size was 5 and the test was terminated at 10,000,000 cycles with four intact samples remaining.

In comparison, eight 3/4" Crosby chain shackles were shot peened and cycled between 2000 and 6000 pounds. The first and only failure occurred after 5,000,000 cycles. Six of the remaining 7 shackles were further tested and all reached 7,727,410 cycles without any failures. Of those six, four were randomly selected and cycled to 14,000,000 cycles without any failures. Based on these results, the shot peening process seemed to greatly improve the fatigue life of the 3/4" shackles tested.

A drawback of the shot peening process is that the component should not be galvanized after shot peening. Temperature associated with hot dip galvanizing will stress relieve the component and negate the effects of the shot peening. An alternate means of corrosion protection is therefore needed. A baked-on coating called Xylan is one technique presently

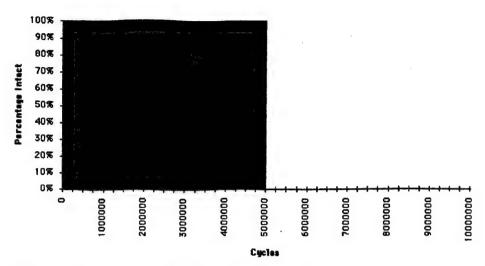
Figure 4p. 3/4" Chain cycled between 2000 and 6000 pounds. The blackened section depicts the percentage of samples intact at the cycles indicated. The sample size was 4 and the test was terminated at 5,000,000 cycles with four intact samples remaining.

Four samples of 3/4" diameter Campbell System 3 proof coil chain were cycled between 2000 and 6000 pounds for a total of 5 million cycles without any failures. Based on these results the System 3 chain was specified for the Arabian Sea surface mooring.

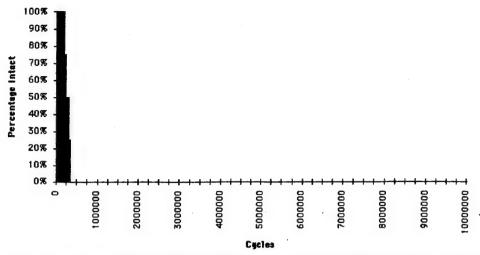
Figure 4r. 7/16" Torque Balanced Wire Rope cycled between 400 and 6800 pounds. The blackened section depicts the percentage of samples intact at the cycles indicated. The sample size was 4 and the test was terminated at 344,320 cycles with no intact samples remaining.

Two series of wire rope tests were conducted. The number of cycles to failure for the first series of tests cycled between 400 and 6800 pounds seemed surprisingly low. Examination of the failures indicated that the wire had not been properly swaged since the breaks had occurred inside the swage socket. It was attributed to an incorrect filler wire size and to an improper technique used by the operator to work the swage onto the wire. During the second series of wire tests which cycled the wire between 2000 and 6000 pounds the test was terminated after the first two breaks. The first break occurred at 995,470 cycles and the second was at 2,594,840 cycles. Fatigue data from these tests were combined with data collected by the US Steel Corporation (Lucht and Donecker, 1977). The S/N diagram shown in Figure 7 includes both the US Steel data and the WHOI results. The same data analysis techniques used to produce the S/N diagram for the weldless sling links and safety shackles were also used for the wire rope S/N diagram.

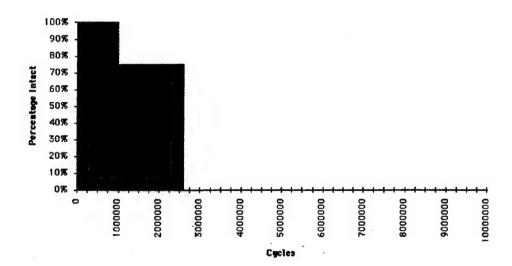
Figure 4s. 7/16" Torque Balanced Wire Rope cycled between 2000 and 6000 pounds. The blackened section depicts the percentage of samples intact at the cycles indicated. The sample size was 4 and the test was terminated at 2,594,840 cycles with two intact samples remaining.

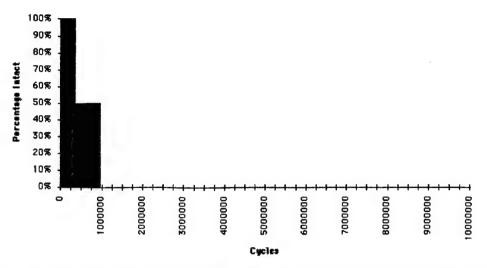
Figure 4t. VMCM-like cage with shortened 3/4" cage rods cycled between 400 and 6800 pounds. The blackened section depicts the percentage of samples intact at the cycles indicated. The sample size was 2 and the test was terminated at 967,080 cycles with no intact samples remaining.

Two test cages were fabricated by Stonebridge Corp. using the same drawings previously used to fabricate a number of other VMCM cages. These cages were initially tested from 400 to 6800 pounds and the first failure occurred after just 351,240 cycles. The early failure was attributed to a fabrication technique that was not appropriate for the type of service expected of these cages. Having identified the problem it became clear that the cage fabrication specifications had to be spelled out more clearly. With the help of Stonebridge Corp. the appropriate welding specifications were identified. In addition dye penetrant inspection of all welds was required by a certified inspector and certification of the origin of the material was also required. The specifications adopted for cage fabrication are as follows:

- All cages are to be welded per MIL-STD-2219 Class C. Certification is required.
- All welds are to undergo liquid penetrant inspection per MIL-STD-6866. Certification is required.
- The type 316 stainless steel must conform to MIL Spec number QQ-S-763 for bar stock and MIL Spec number QQ-S-766 or ASTM-A-240 for sheet or plate. Material certification is required.
- All rod stock must be a continuous piece.
- Finished products should be stamped with the welder's certification number and the designation for liquid penetrant inspection.
- Parts will not be accepted for use on moorings without the above mentioned certifications.

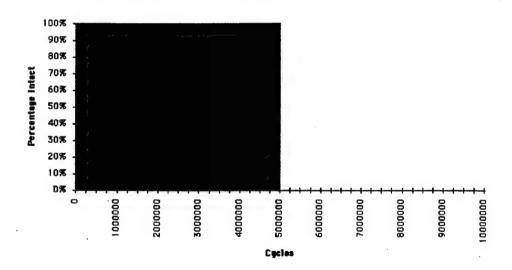
Figure 4u. VMCM-like cage with shortened 3/4" cage rods cycled between 2000 and 6000 pounds. The blackened section depicts the percentage of samples intact at the cycles indicated. The sample size was 2 and the test was terminated at 5,000,000 cycles with two intact samples remaining.

Two new test cages were fabricated using all the new specifications and the gussets. These cages were tested between 2000 and 6000 pounds. After 5 million cycles neither cage had failed and the test was terminated. Since the second set of test cages had performed so well, ten existing cages (enough for two Arabian Sea deployments) were retrofitted with gussets and all welds were brought up to the new specification and inspected.

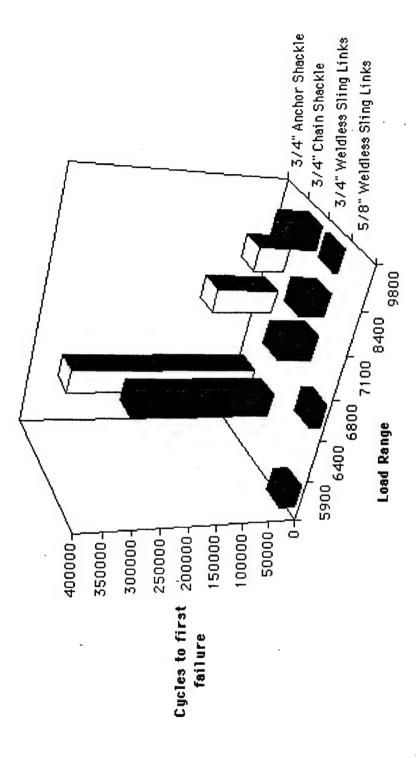
Due to the expense of conducting the fatigue tests it was difficult to obtain a complete data set whereby all components are tested for all ranges. Figure 5 shows for 5/8" and 3/4" weldless sling links and 3/4" chain and anchor shackles a plot of cycles to first failure as a function of load range. The combined plot clearly shows the trend that as the load range increases the number of cycles to first failure decreases. A relatively small increase in load range can significantly reduce the number of cycles the component can endure. Take, for example, the 3/4" anchor shackle. By increasing the load range from 6400 pounds to 8400 pounds or an increase of 31%, the number of cycles to first failure dropped from 351,000 to 58,000 or by 83%. Hence, moderate increases in the loading on a mooring can greatly shorten its life expectancy.

failure as a function of load range for two types of shackles and two sizes of Figure 5. Three dimensional representation of the number of cycles to first. weldless sling links.

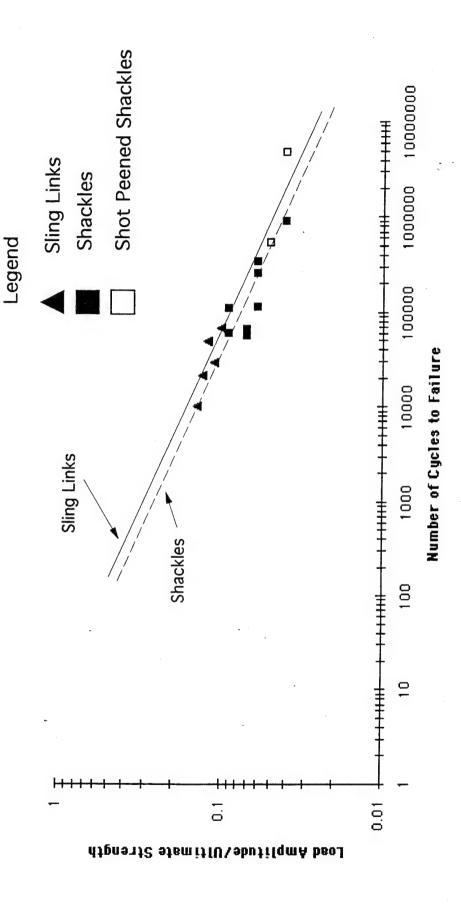
Figure 6. S/N diagram for shackles and sling links

Fatigue data are often presented in the form of S/N curves where the cyclic stress amplitude is plotted versus the number of cycles to failure. An S/N curve was generated from the data obtained during the fatigue tests of weldless sling links and safety shackles. Since the failure of any single component in line on a mooring is catastrophic we have taken a conservative approach here and used the number of cycles to the first failure. Seven different load ranges were used in the fatigue tests. The means of the load ranges were all very close to 4000 pounds. To account for the small differences in the mean loads, an adjustment was made to the actual test amplitude (y) using:

which assumes that the number of cycles to failure (N) is related to the amplitude of the dynamic tension (T), we have determined the values of y and q for both types of components. The parameters of q and y are fatigue constants related to the material and geometry of the given mooring component. Sling links can be represented using y=1.8Yu, and q=3.8 and safety shackles by y=1.5Yu and q=3.8 where Yu is the ultimate strength of the given component (Grosenbaugh, 1995).

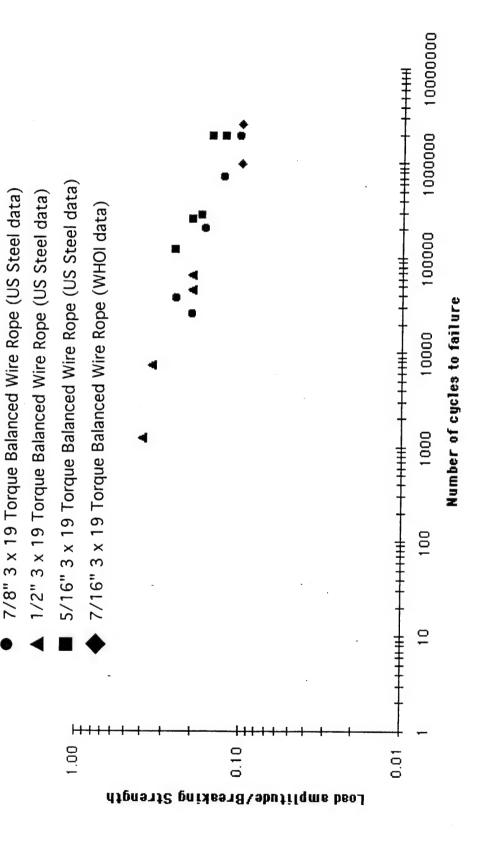
Figure 8. S/N diagram for 3 x 19 torque balanced wire rope. Load amplitude is the actual amplitude used during the cyclic testing.
